World Trade Center Building Performance Study:

*Data Collection, Preliminary
Observations, and
Recommendations*

FEMA 403 / May 2002

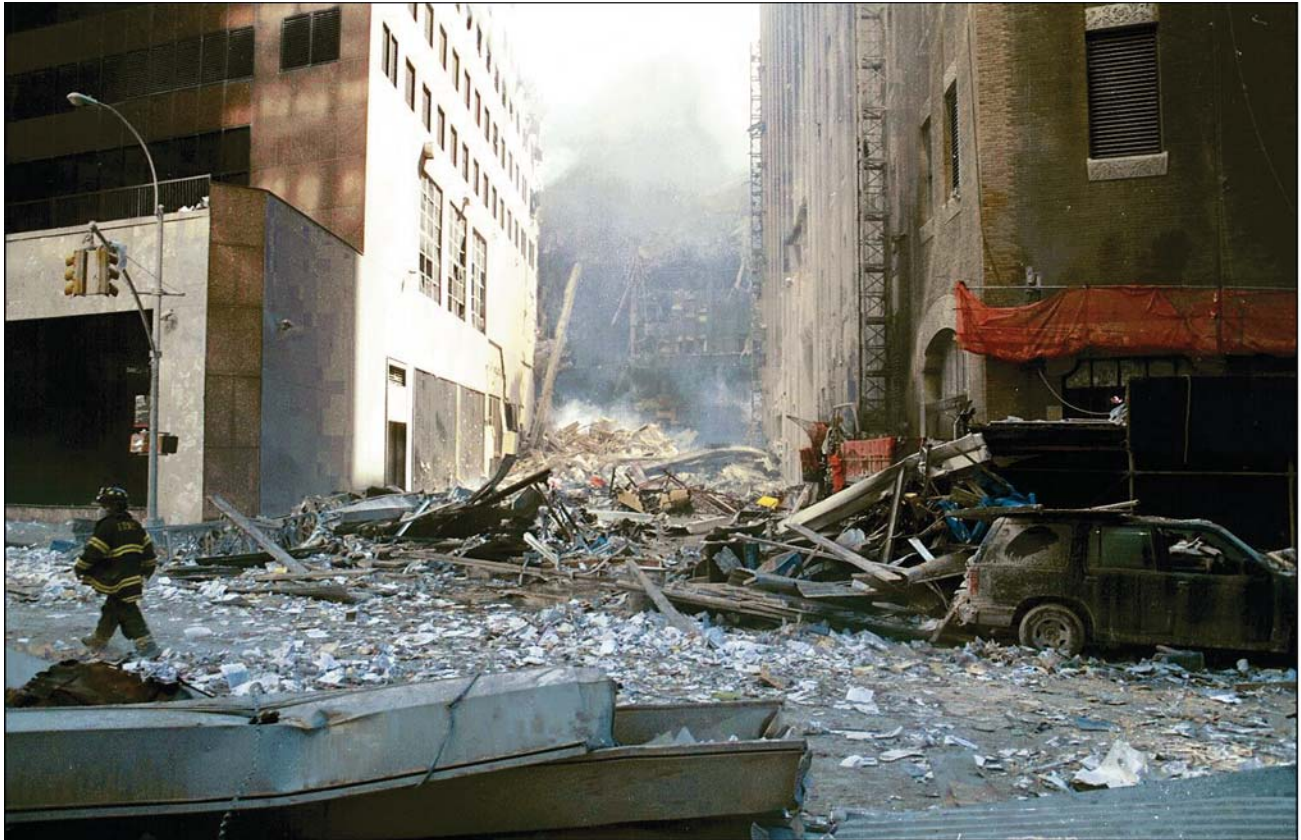
Figure 5-14 is an aerial photograph that shows the debris clouds spreading around WTC 7 just after the collapse of WTC 1. Figure 5-15 is a photograph of WTC 1 debris between the west elevation of WTC 7 and the Verizon building. Figure 5-12(B) shows a plan-view diagram approximating the extent of this debris just after the collapse of WTC 1.

Figure 5-15 Debris from the collapse of WTC 1 located between WTC 7 (left) and the Verizon building (right).

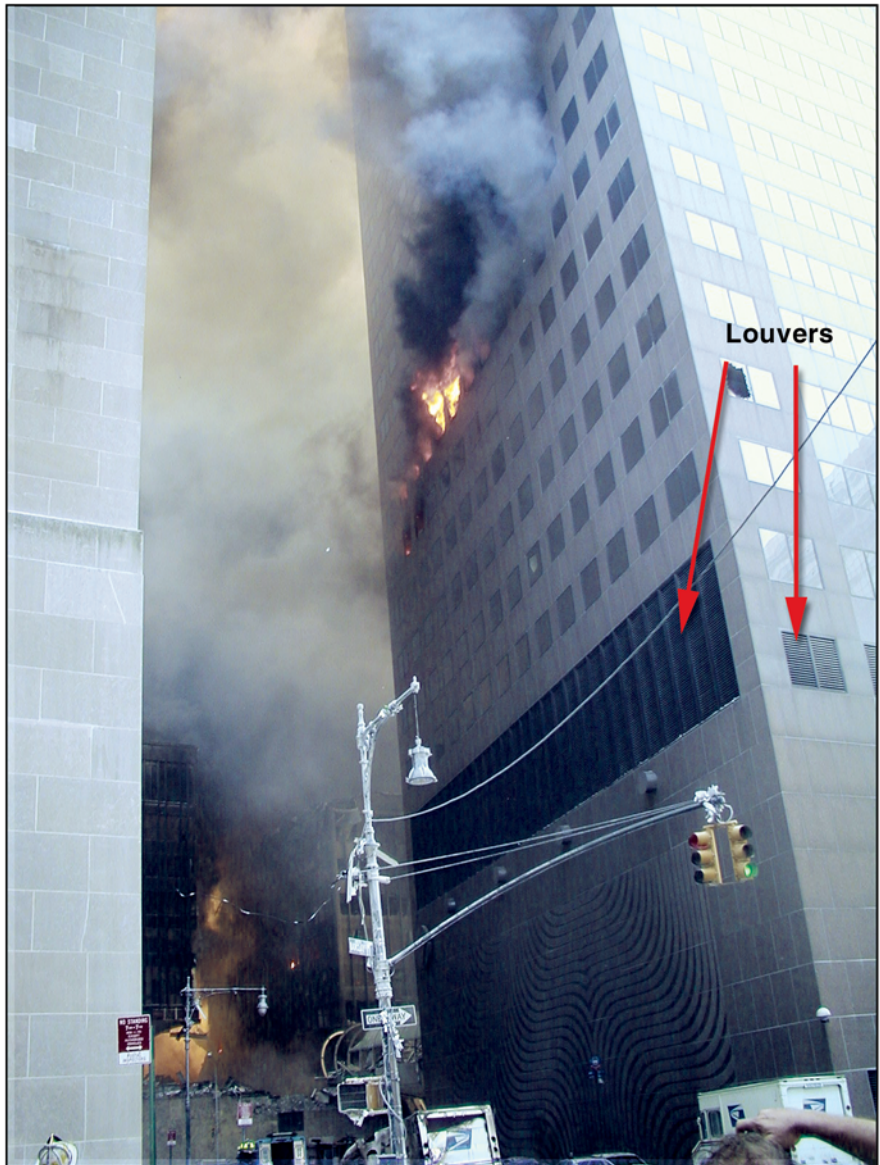
As the day progressed, fires were observed on the east face of the 11th, 12th, and 28th floors (see Figure 5-19). The Securities and Exchange Commission occupied floors 11 through 13. Prior to collapse, fire was seen to have broken out windows on at least the north and east faces of WTC 7 on some of the lower levels.

*Figure 5-19
Fires on the 11th and 12th floors of
the east face of WTC 7.*

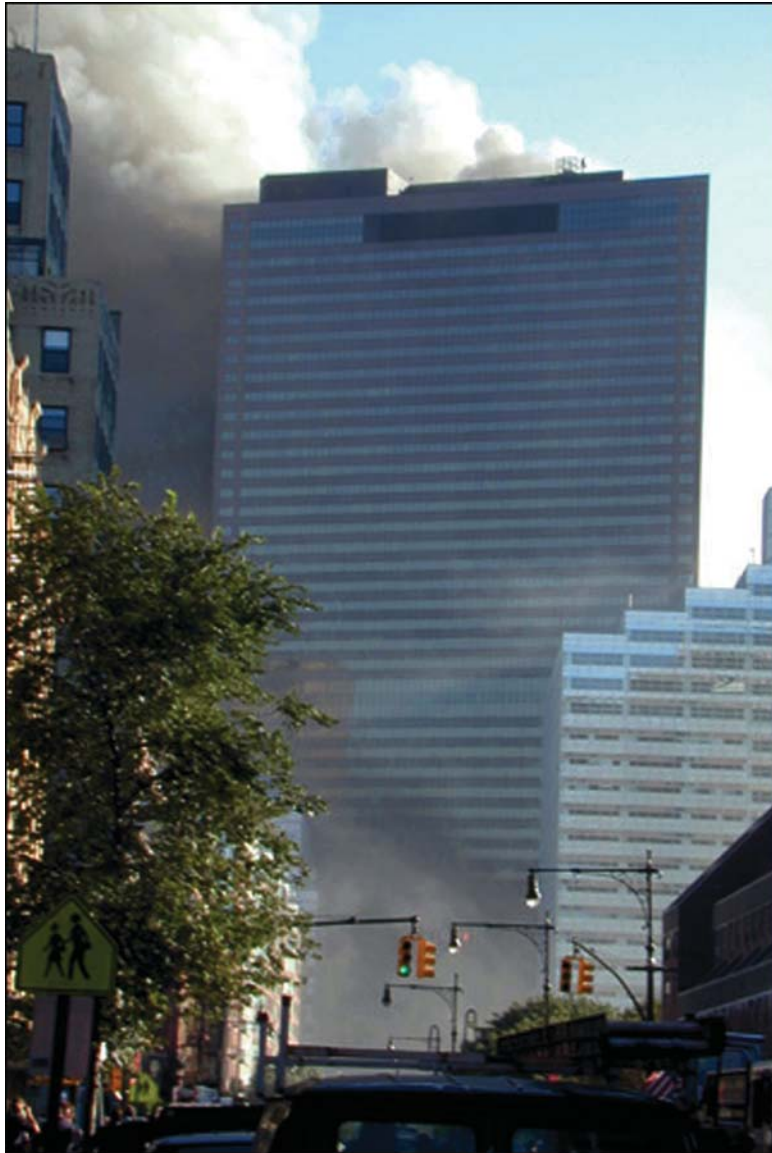
~5:20:33 p.m. WTC 7 begins to collapse. Note the two mechanical penthouses at the roof on the east and west sides in Figure 5-20.

*Figure 5-20
View from the north of WTC 7 with both
mechanical penthouses intact.*

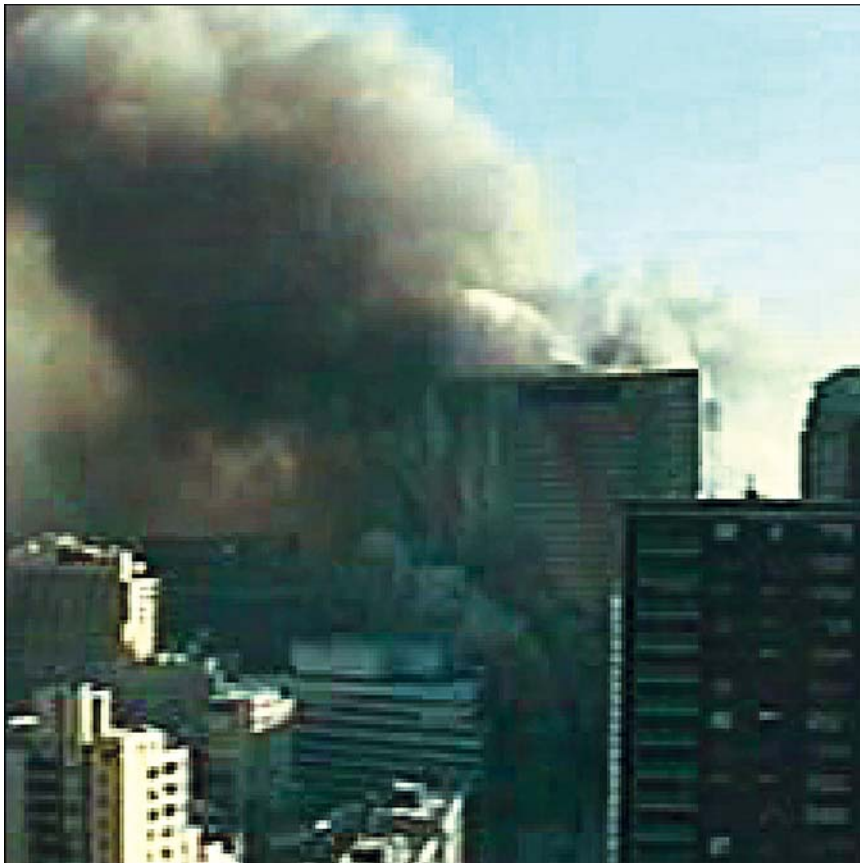
~5:21:08 p.m. Approximately 5 seconds later, the west mechanical penthouse disappears (Figure 5-22) or sinks into WTC 7.

*Figure 5-22
East and now west mechanical
penthouses gone. (From video.)*

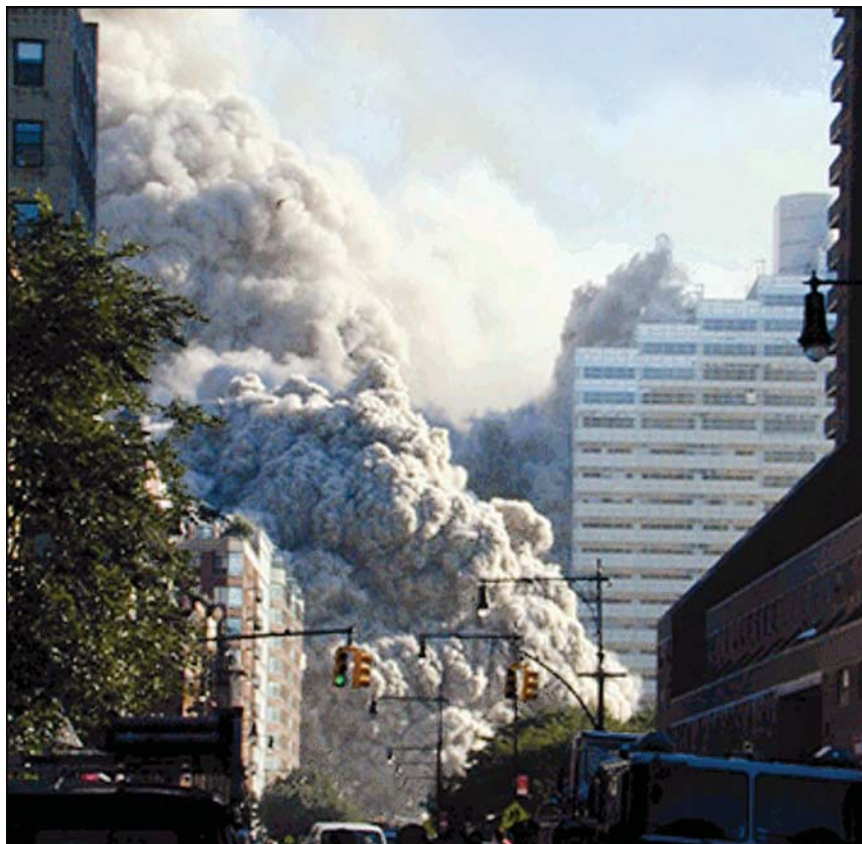
~5:21:10 p.m. WTC 7 collapses completely after burning for approximately 7 hours (Figure 5-25). The collapse appeared to initiate at the lower floors, allowing the upper portion of the structure to fall.

Figure 5-25 Debris cloud from collapse of WTC 7.

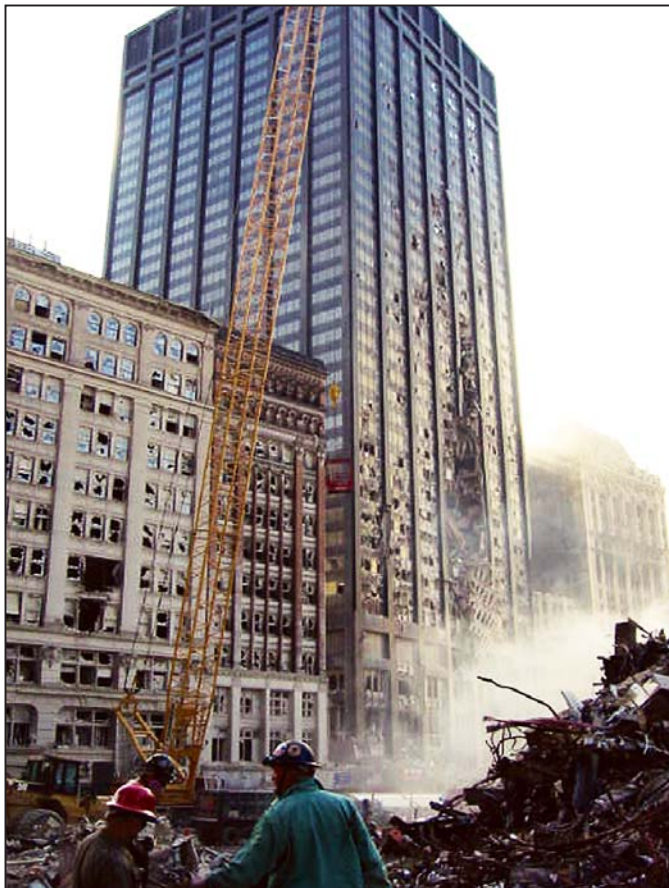
*Figure 6-1
North face of Bankers Trust building with impact damage
between floors 8 and 23.*

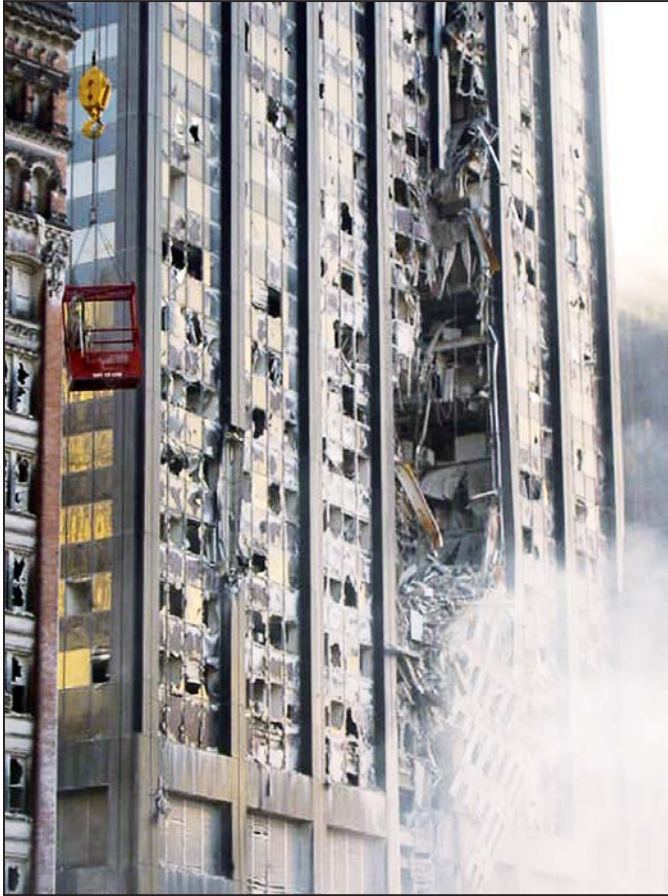
Figure 6-2
Closeup of area of partial collapse. Note debris accumulated at the bottom of the damage area, resting on the 8th floor. Area of initial impact is not shown in this photo.

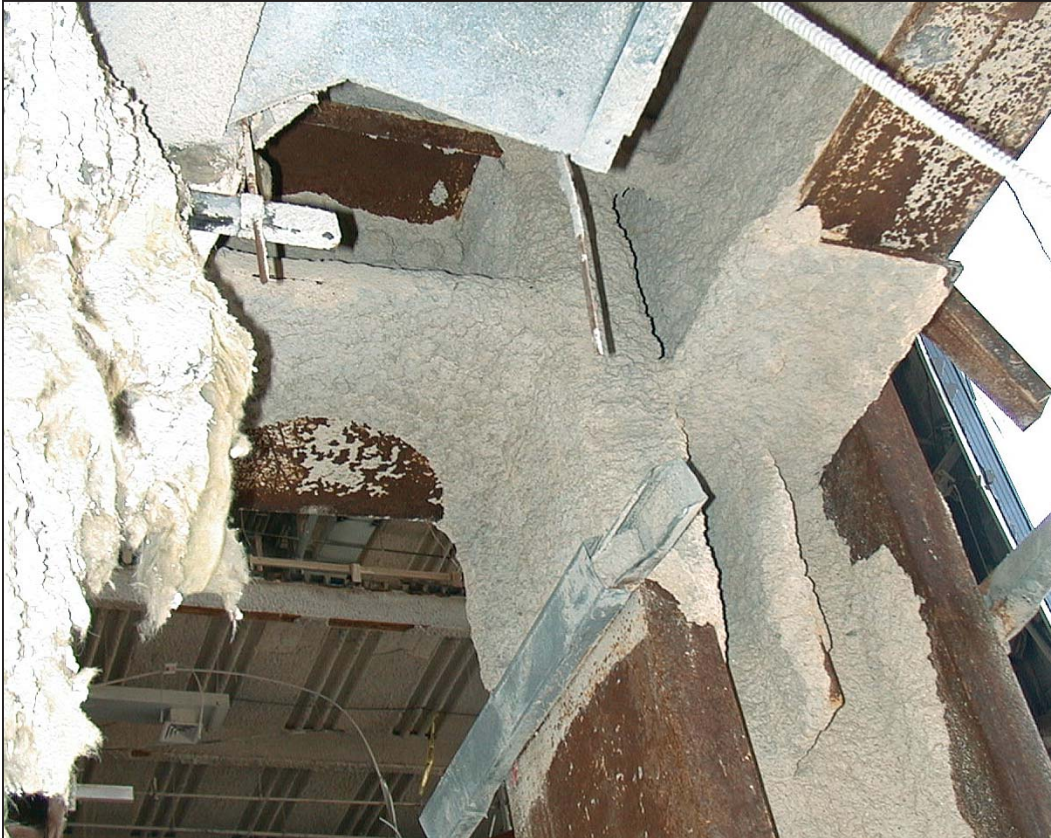
Figure 6-6 Moment-connected beams to columns.

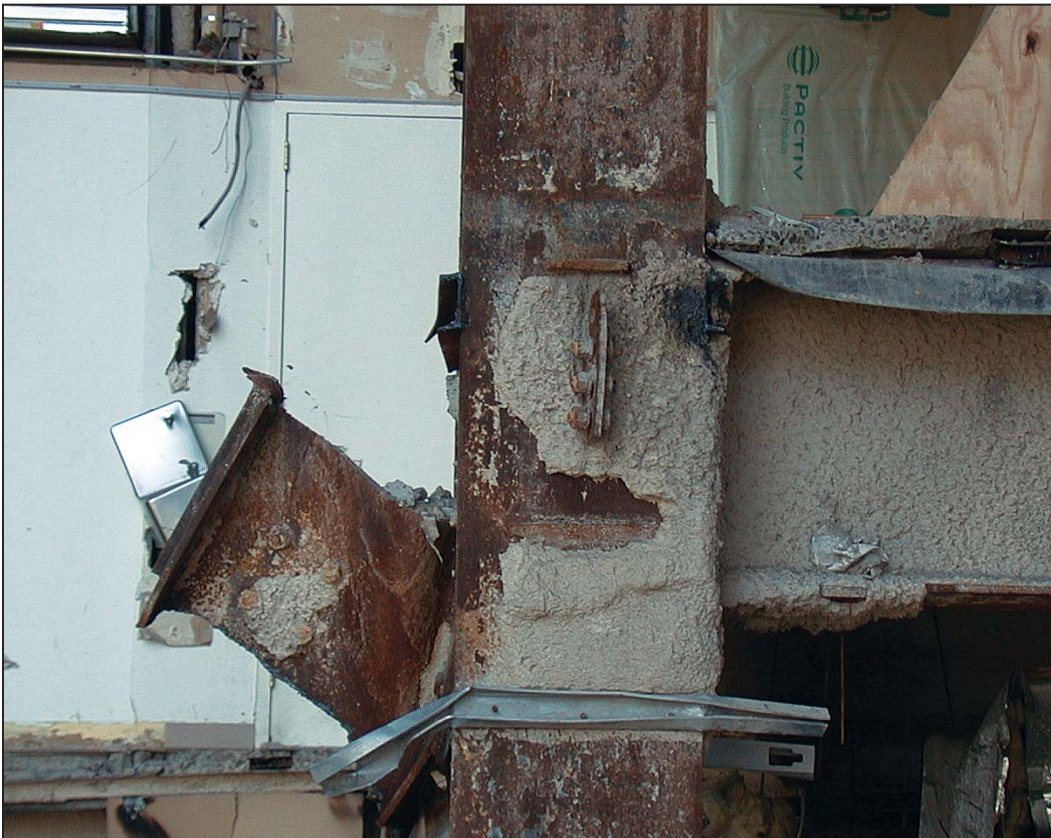
Figure 6-7 Column with the remains of two moment connections.

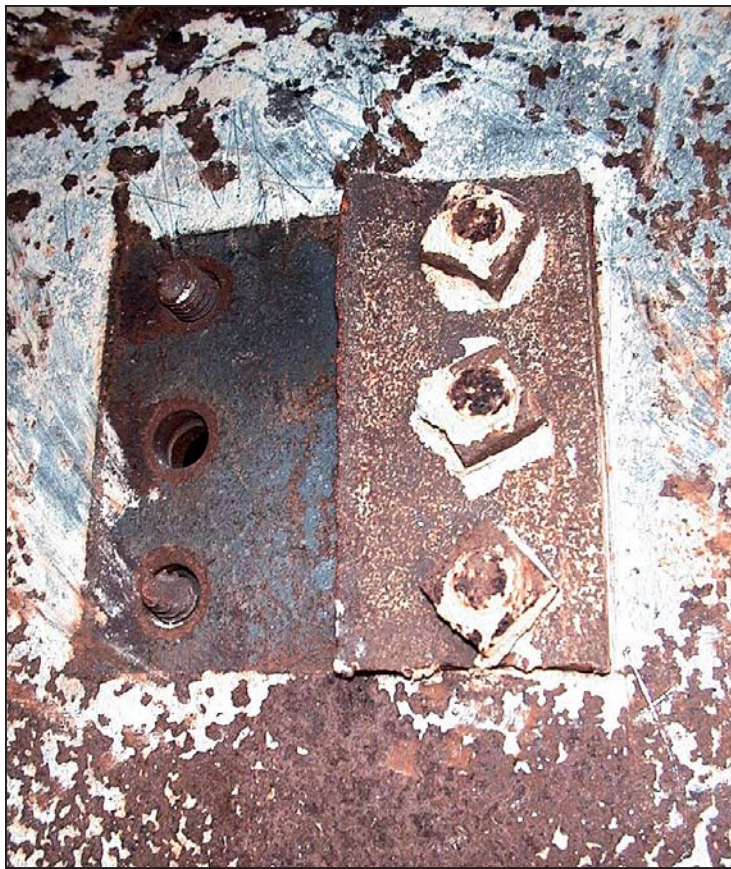
Floor-beam-to-girder connections typically used a partial-depth end plate welded to the floor beam web and bolted to the girder with A307 bearing bolts. Typically, failure occurred in one of two modes, either the bolts were overloaded in tension and the connection pulled off, or the partial end plate sheared at or near the weld line. At most of the connections, it appears there was some amount of bolt failure. Figure 6-8 shows a shear connection with half of the end plate remaining in place.

Figure 6-8
Failed shear connection of beam web to column web.

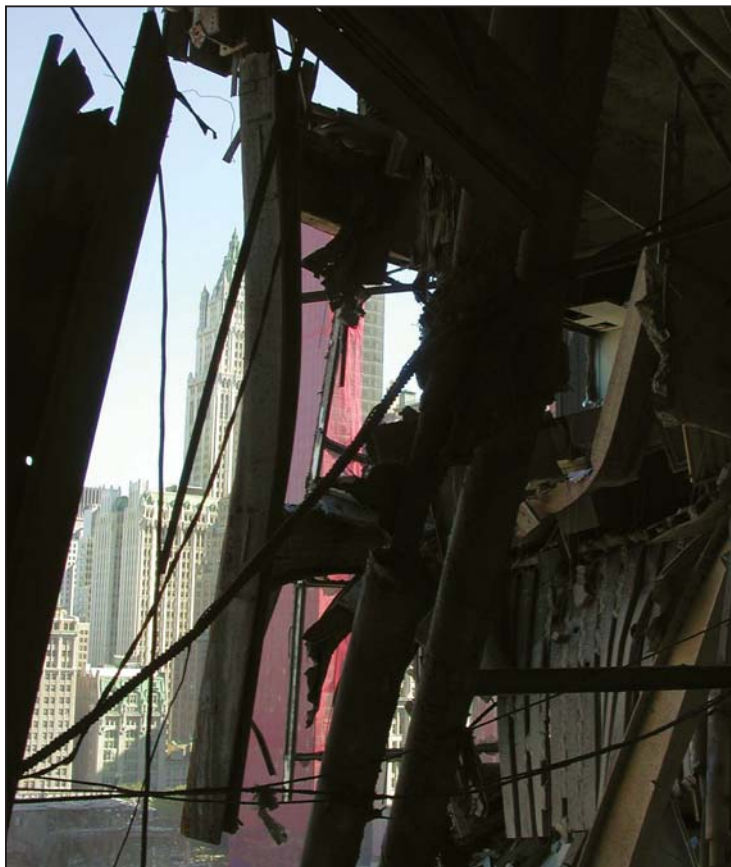
Figure 6-9
Suspended column D-8 at the 15th floor. Note separation at column splices.

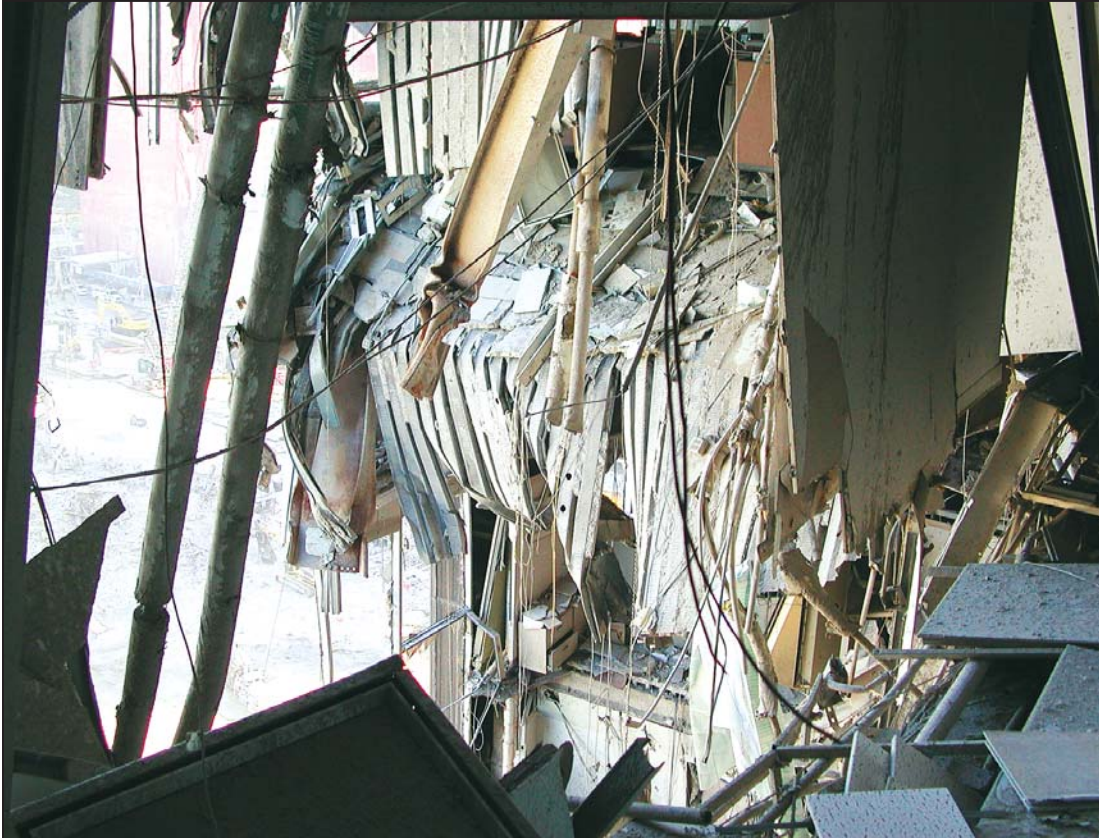
Figure 6-10 Area of collapsed floor slab in bays between C-8, E-8, C-7, and E-7, from the 15th floor.

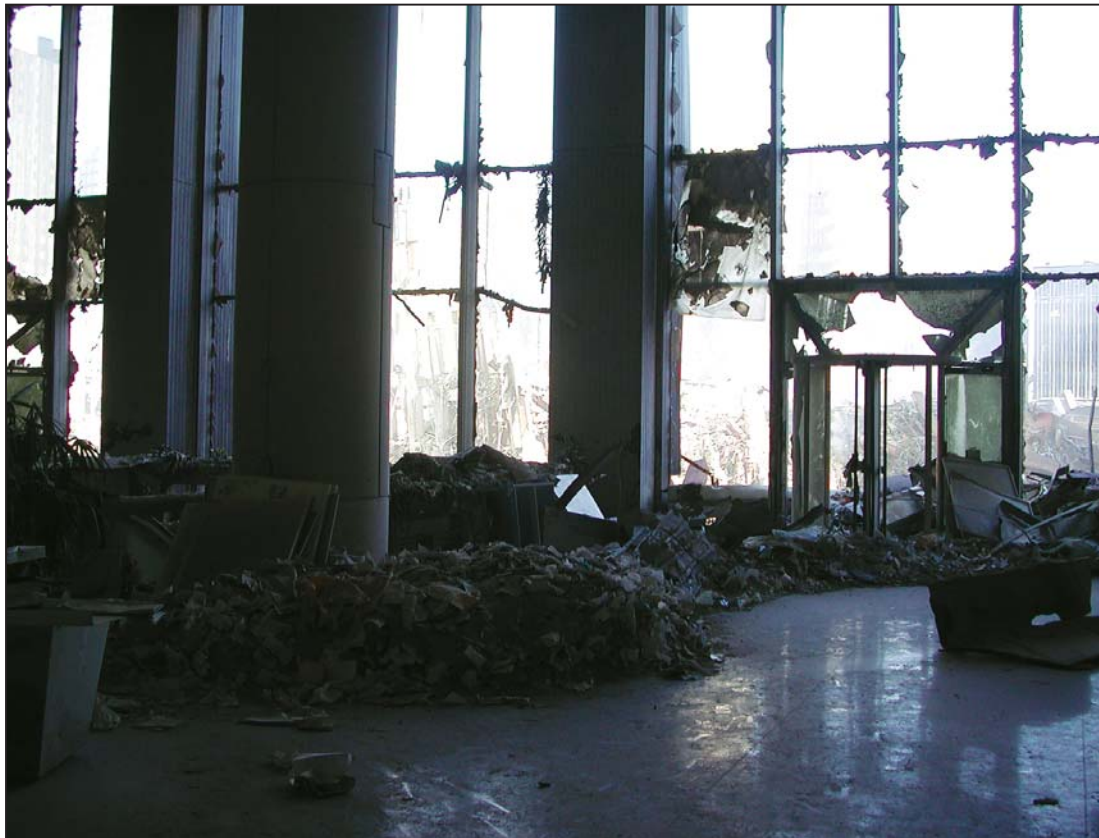
As the spandrel connections failed and the floor slabs collapsed, a portion of the rubble accumulated into a two-story pile while the remainder fell out of the building onto the low-rise roof on the north side of the building. The impact debris finally came to rest on the two-story-deep pile of debris that was on the 8th floor. Figures 6-9 and 6-10 illustrate the damage. A major component of WTC 2, approximately 40 feet tall by 30 feet wide, remained lodged in the debris pile and was clearly visible as it hung from the face of the building. Yet despite this weight, the floor supporting the debris deflected a maximum of 6 inches. Figure 6-11 shows the extent of debris in the lobby of the building.

Figure 6-11 Bankers Trust lobby (note debris has been swept into piles).

After the exterior glazing was penetrated by the debris, the dust cloud resulting from the collapse of the towers deposited a layer of dust an inch or more thick throughout the northern part of the building. The 2nd floor lobby area had extensive broken glass, general debris, and dust (Figure 6-11). Figure 6-12 shows a typical office near the collapsed area at the 8th floor.

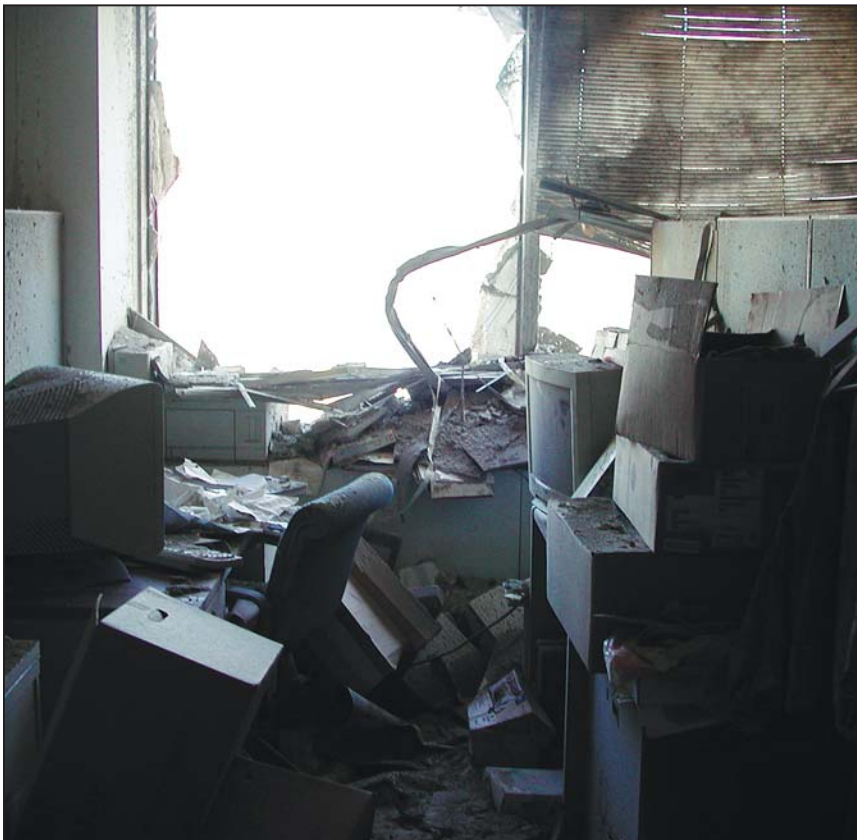
*Figure 6-12
Office at the north side of the 8th floor.*

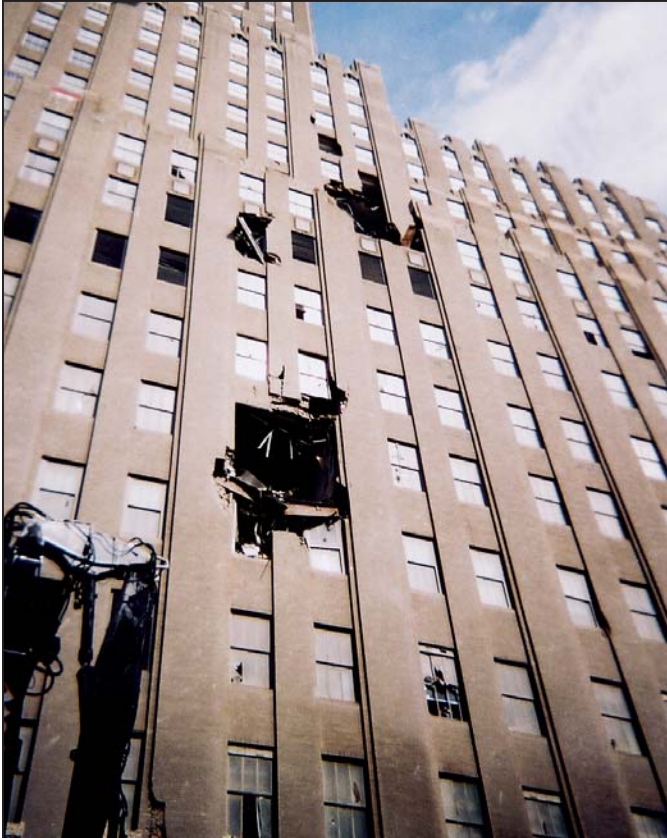
The south (Vesey Street) side of the building was damaged from approximately the 13th floor down, primarily due to the impact of projectile debris from the collapse of WTC 1 (Figure 7-10). In addition to fairly extensive façade damage (bricks and windows), two bays of slab and framing were damaged at the sidewalk arcade at the 1st floor, and one bay of slab and framing (including spandrel beams) was damaged at the 6th, 7th, 9th, 11th, 12th, and 13th floors (Figures 7-11 and 7-12). In addition, one interior column suffered minor damage below the 1st floor.

Figure 7-10
Verizon building – damage to south elevation (Vesey Street).

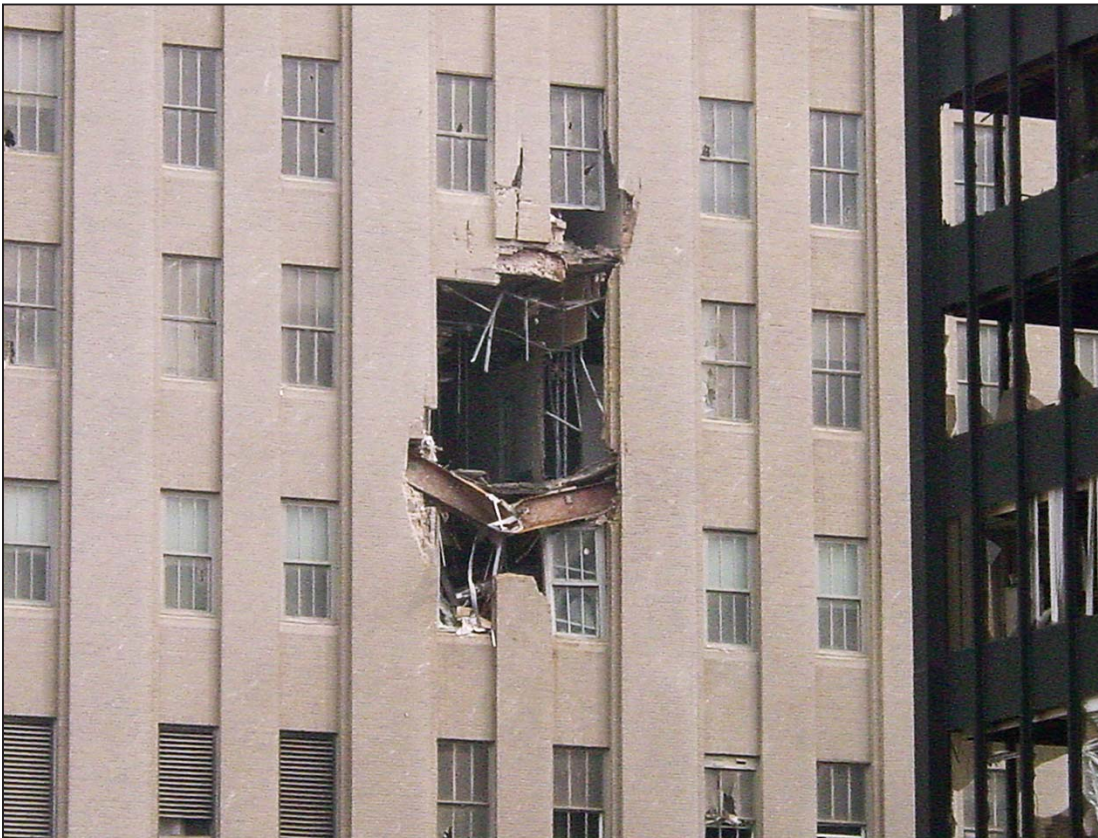
Figure 7-11 Verizon building – localized damage to south elevation (Vesey Street).

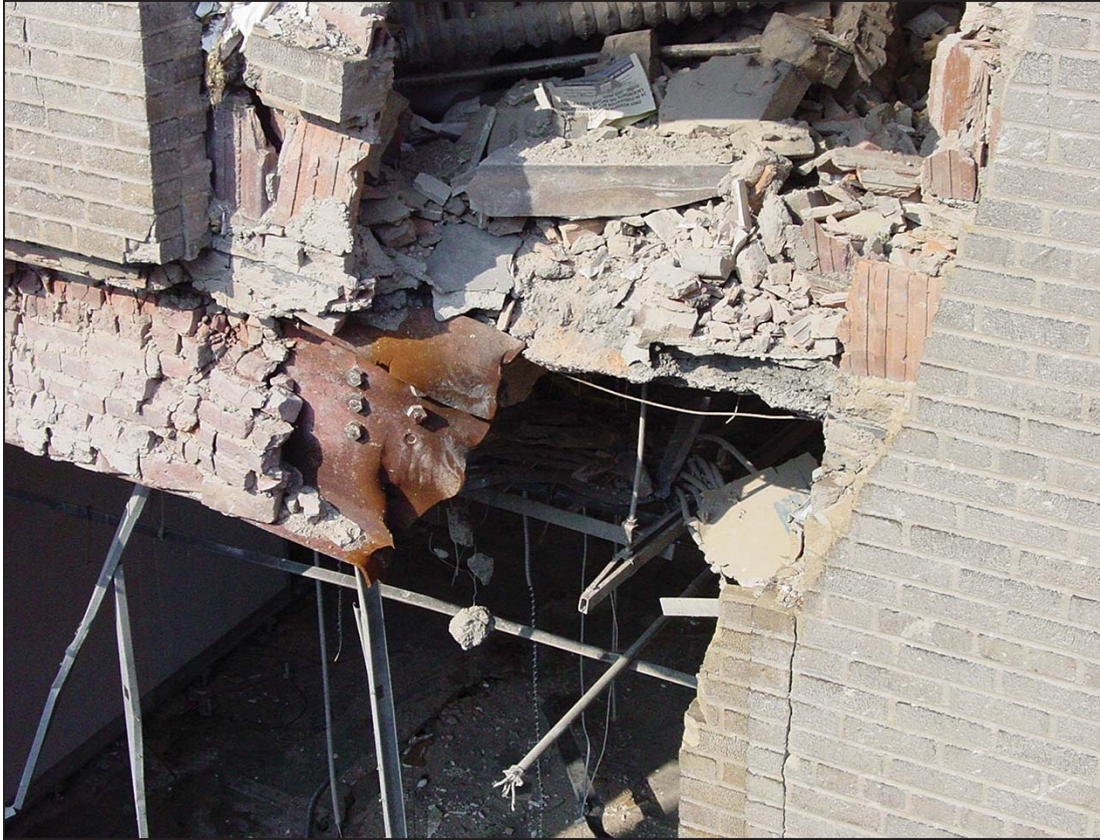
In general, the Verizon building performed well, especially given its close proximity to WTC 7. On the south (Vesey Street) side of the building, damage was extremely localized near the point of impact of projectile debris. In some cases, only a short section of spandrel beam and small area of floor slab were damaged, leaving the remainder of the structural bay intact (Figure 7-12).

Figure 7-12 Verizon building – detail of damage to south elevation (Vesey Street).

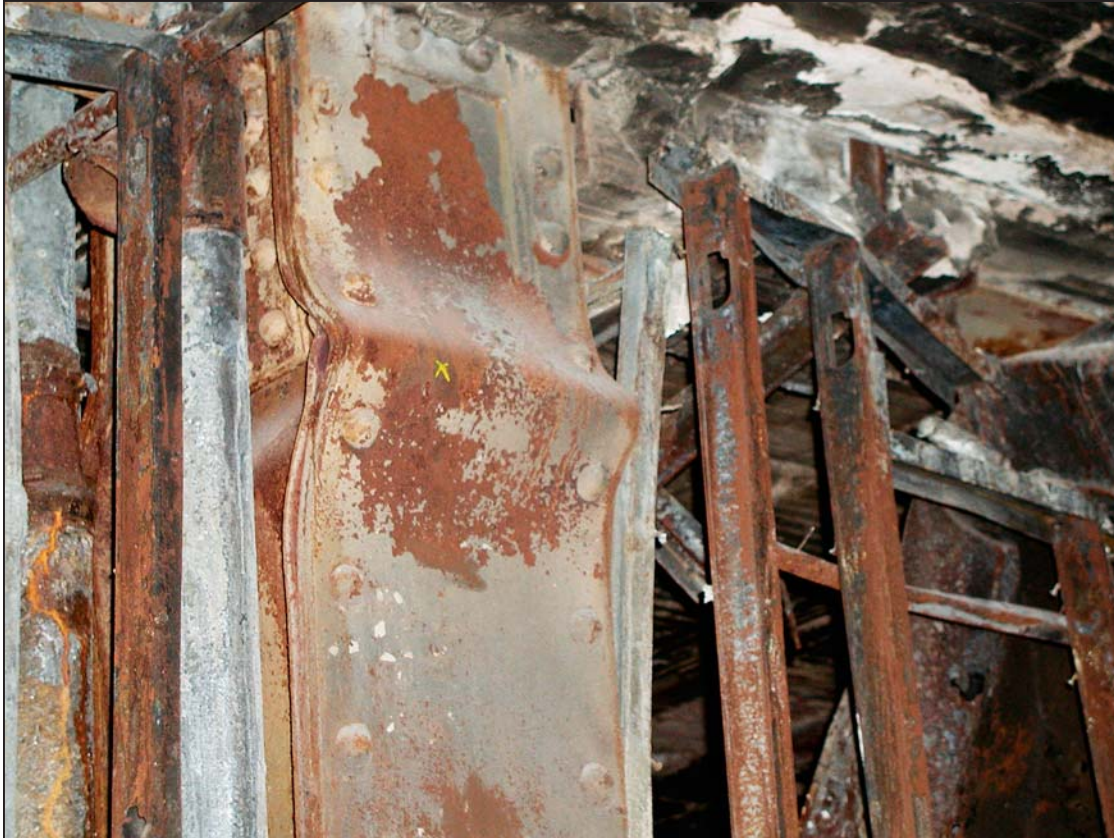
Figure 7-17 Buckling damage at top of column on floor 23 of 90 West Street.

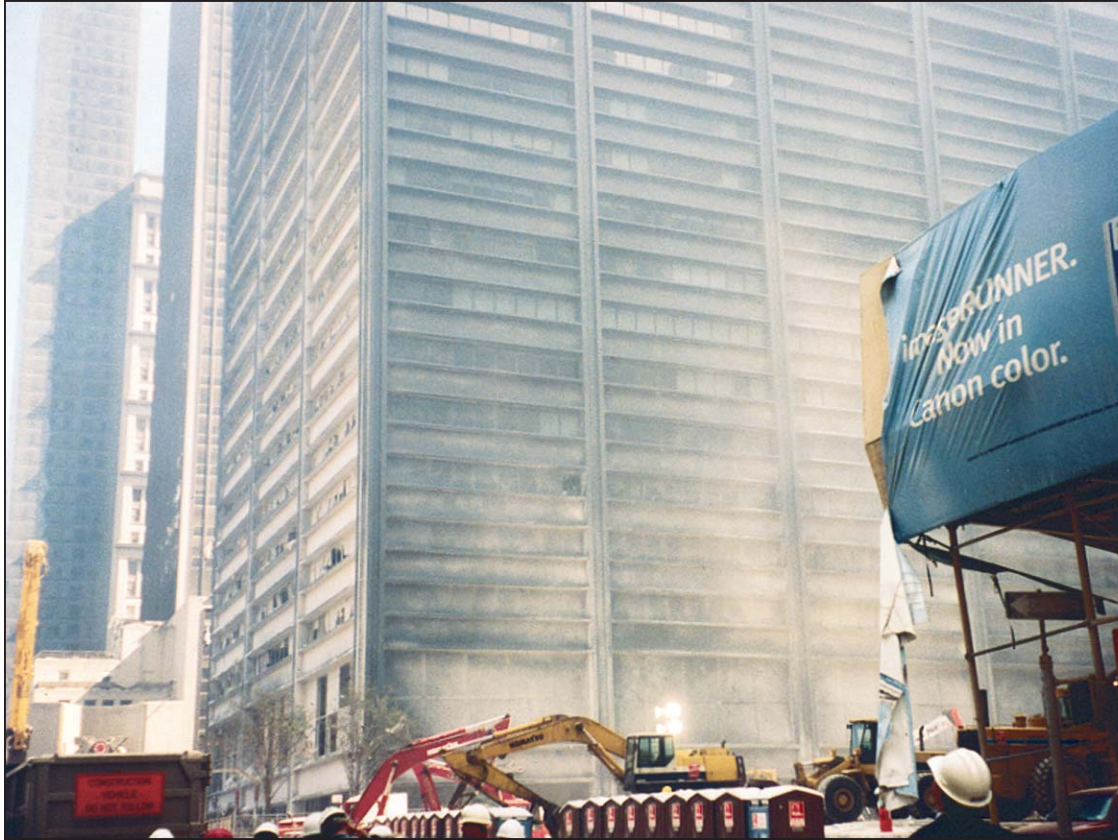
One Liberty Plaza (One Liberty) is a 54-story, 730-foot-high building, comprising a footprint of 238 feet in the north-south direction by 163 feet in the east-west direction. The building area is approximately 2,000,000 square feet (Figures 7-18 and 7-19). It was designed by Skidmore, Owings, and Merrill in 1970 and served as corporate headquarters for U. S. Steel Corporation.

On September 12, there was a persistent rumor that One Liberty was still in danger of collapse. The building was inspected by structural engineers conducting building surveys and safety evaluations of buildings around the WTC site. The building vertical alignment was measured with a transit to determine whether any lateral drift had occurred along the height of the building. Three locations on the west face were evaluated, and no apparent movement was observed in the building. The One Liberty Plaza building was determined to be safe, except for dangers related to broken glass.

Figure 7-18 One Liberty Plaza – south elevation, lower floors.

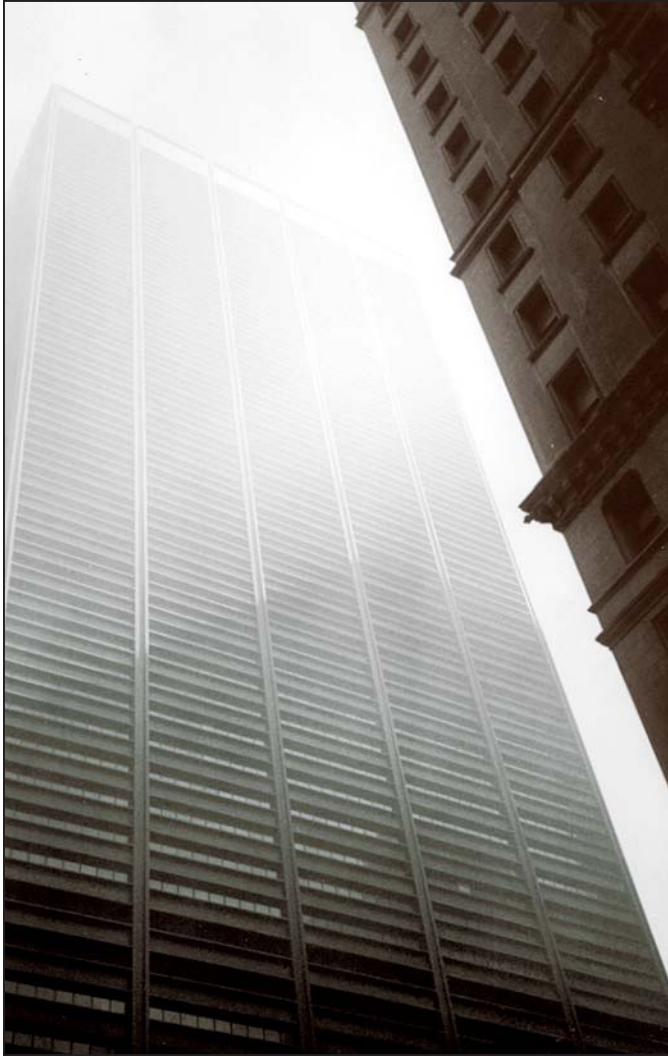
Figure 7-19
One Liberty Plaza – south elevation, upper floors.

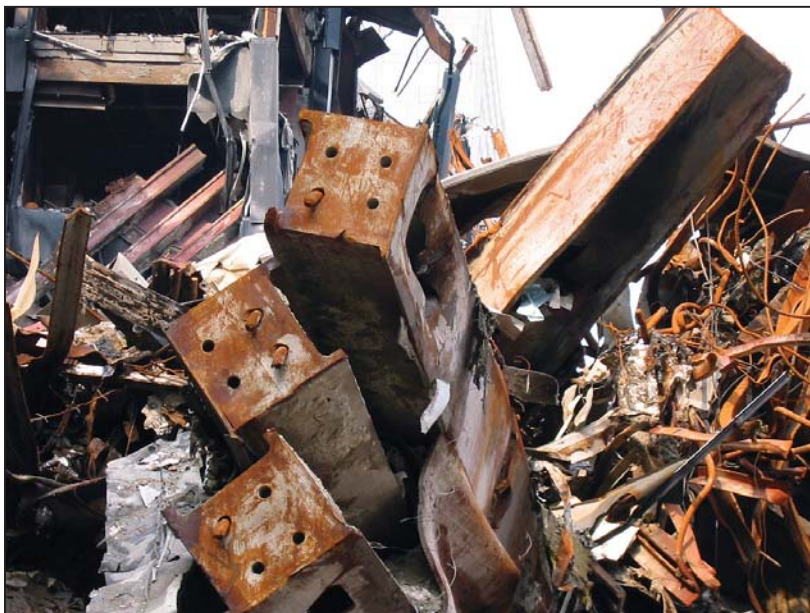
high. The cross-sectional shape of the columns can be seen in Figure B-1. These varied in length from 12 feet 6 inches to 38 feet, depending on the plate thickness and location.

Figure B-1 Exterior column end plates.

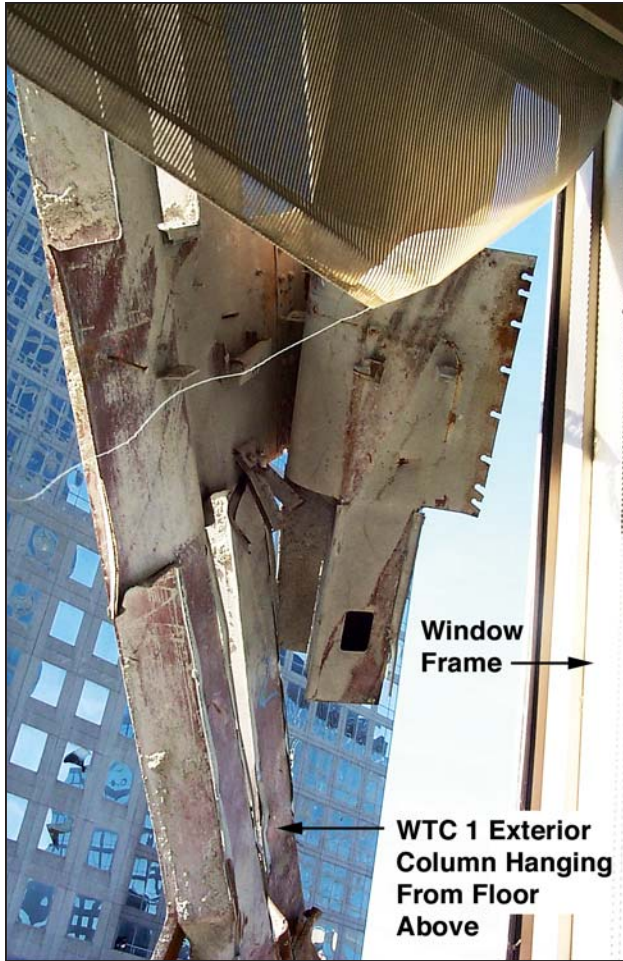
Other failure modes are possible as bolts transfer forces from one component into another by bearing and shear of the fastener. This can result in bearing deformations and net section fracture of the connected elements. Other failure modes are shear rupture or bearing strength as bolts shear connected material between the bolt and a plate edge, or block shear, which combines the tension and shear resistance of the connected elements. An example of one of these failure modes can be seen in Figure B-5, which shows a spandrel beam bolted shear connection that has failed in end zone shear as the connection was subjected to moments and/or tensile loading. This indicates that all elements in this example were at their ultimate load capacity when the spandrel connection failed.

Figure B-5
Column tree showing bolt bearing shear failures
of spandrel connection.

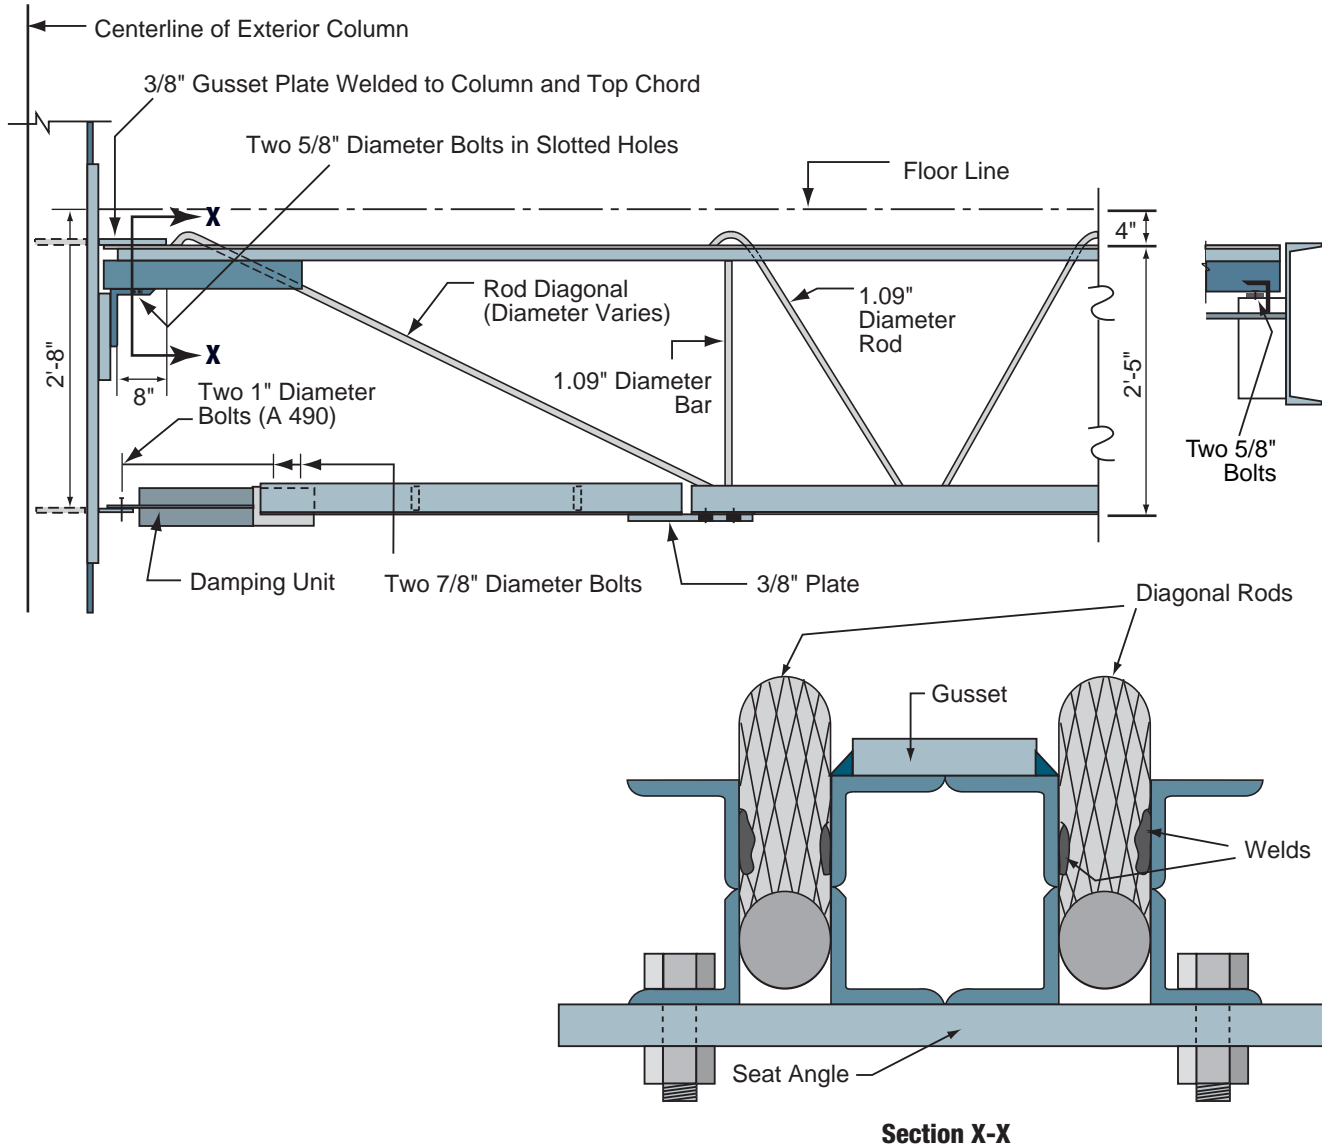
Figure B-8 Typical truss top chord connections to column/spandrel beam and to the core beam.

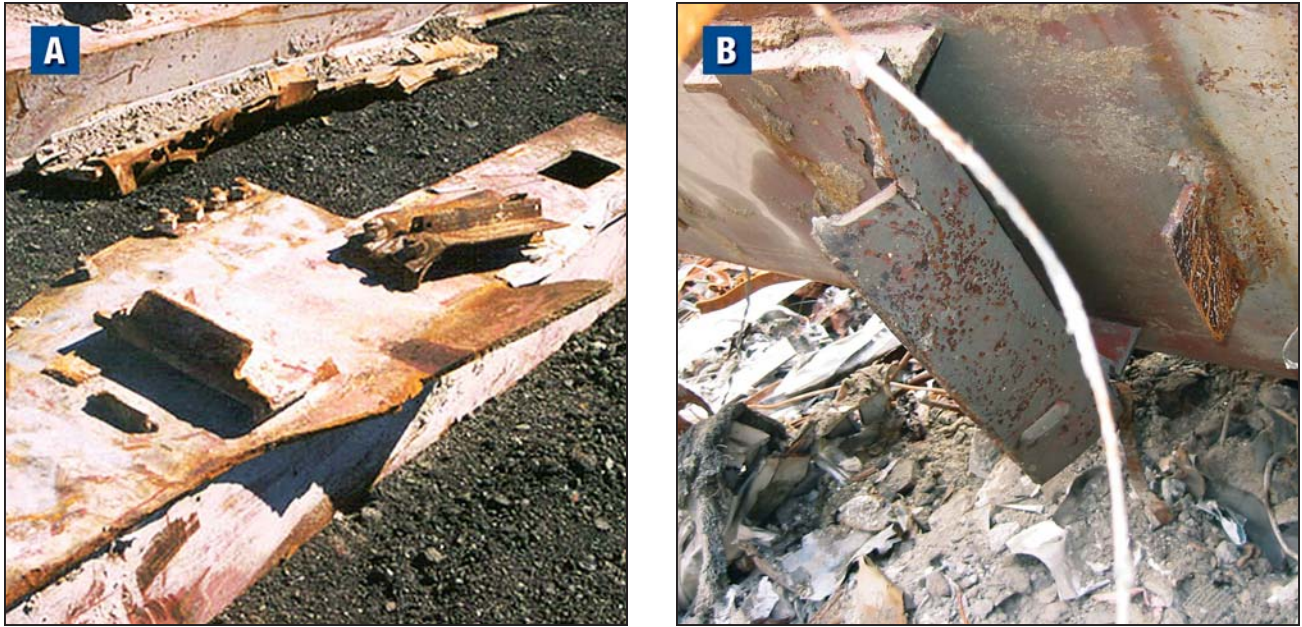
Figure B-9 shows several of the failure modes of the truss connections to the chord bearing seat and spandrel beam. The gusset plate welded to the spandrel beam and the top chord failed by tensile fracture of the plate. The gusset plate connection was primarily resisting the floor diaphragm support to the column. After fracture, the slotted holes in the seat would allow rigid body motion of the trusses until the 5/8-inch bolts came into bearing. That resulted in partial fracture in the seat of the fillet welds attaching the fill plate to the spandrel beam. The seat angle welded connection to the fill plate remained intact as this separation occurred and final block shear failure developed in the outstanding angle leg at the two slotted bolt holes.

It is probable that, once the 3/8-inch gusset plate fractures, the next lower bound resistance is provided by the bearing capacity of the two 5/8-inch bolts on the beam seat angle. This failure also tore off the ends of the angle even though the tensile capacity of those segments was predicted to be higher.

Figure B-9 (A) Visco-elastic damper angles bolted to angle welded to spandrel plate and (B) failed bearing seat connection.

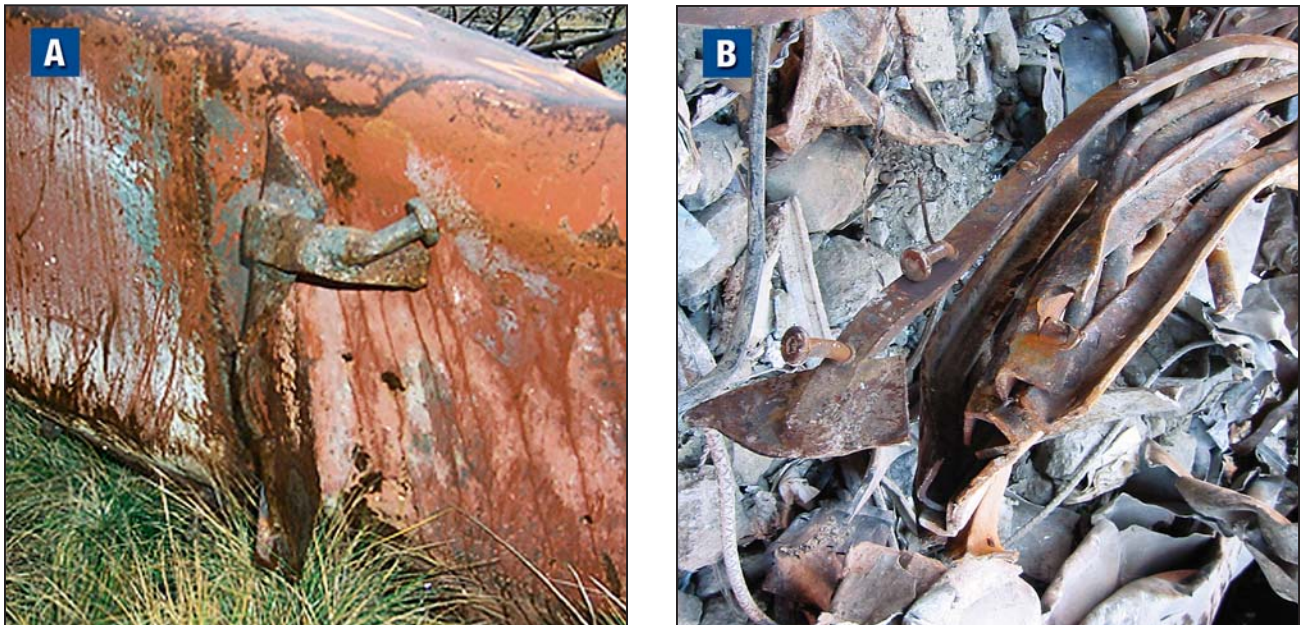
It should also be noted that each truss top chord provided a horizontal diagonal plate brace (1-1/2 inches x 1/2 inch) to the two adjacent columns. These members were welded to welded bracket plates on each adjacent column/spandrel member, as illustrated in Figure B-10. In this case, it would appear that the diagonal plate braces fractured on their gross section or tore the bracket plate. The component of ultimate strength of the two diagonal plate braces normal to the column/spandrel member is about 85 percent of the tensile capacity of braces, which would be 76 kips.

Figure B-10 (A) Bracket plate welded to the column/spandrel plate and (B) horizontal plate brace with shear connectors welded to the failed bracket.
